## Wembley Hill Road / Park Lane, Brent, London

### Road Safety Audit Stage 1

on behalf of London Borough of Brent

**TMS reference no: 15474**

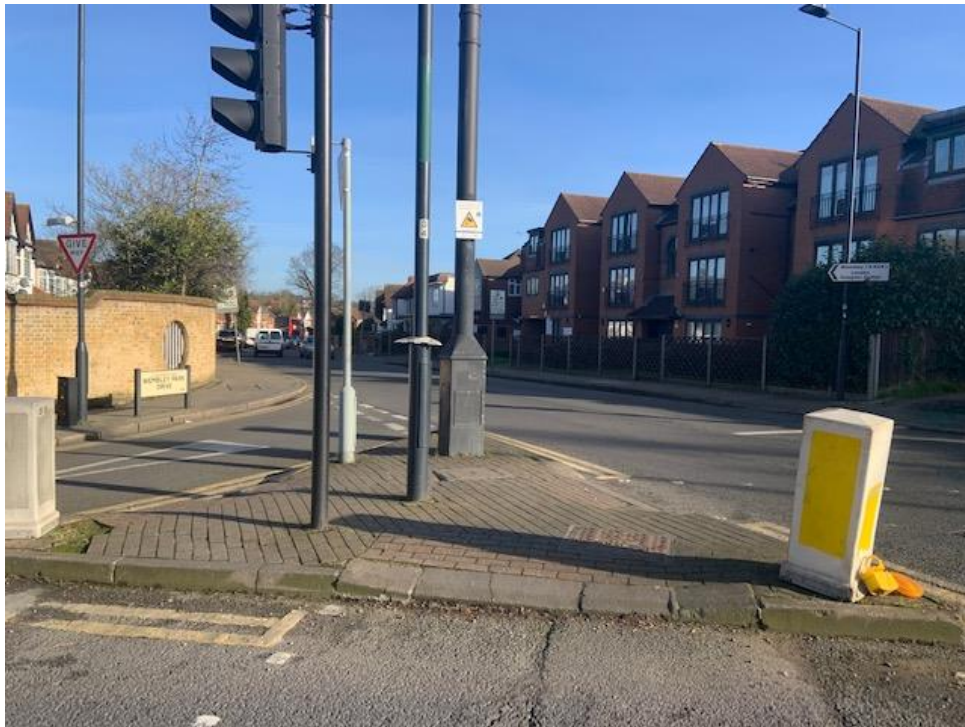
### 2.1 PROBLEM

Location – Wembley Hill Road / Wembley Park Drive

Summary: Potential hazard and obstruction to pedestrians

On the splitter island between Wembley Hill Road and Wembley Park Drive there are numerous items of street furniture (CCTV pole and lighting column). When this area is built out and the pedestrian crossings are introduced, these items may be a hazard and obstruction to pedestrians trying to negotiate the crossings. This may be an issue, to pedestrians particularly to those with visual and mobility impairments, wheelchair and pushchair users.

At detailed design stage, items of street furniture such as the lighting column and CCTV pole may require relocation to ensure an unobstructed route through the crossings is available to pedestrians.

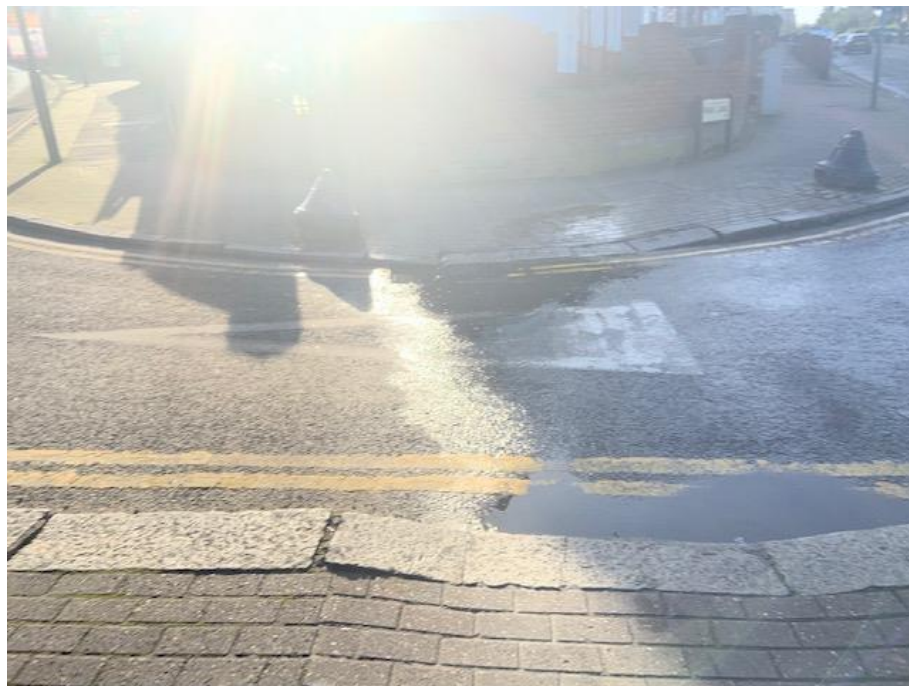
## 2.4 PROBLEM

Location – Wembley Hill Road / Park Lane

Summary: Potential skid hazard to vehicles

It was noted at the site visit that surface water ponding was occurring on the left turn slip from Wembley Hill Road (S) to Park Lane. The removal of the left turn slip and introduction of kerb line will further alter surface water run off in this area. If additional surface water is forced into the junction area, there may be a greater risk of skid hazards to vehicles in heavy rain and icy conditions.

At detailed design stage localised surface water run off should be assessed in conjunction to changing kerb lines and drainage improved as necessary.

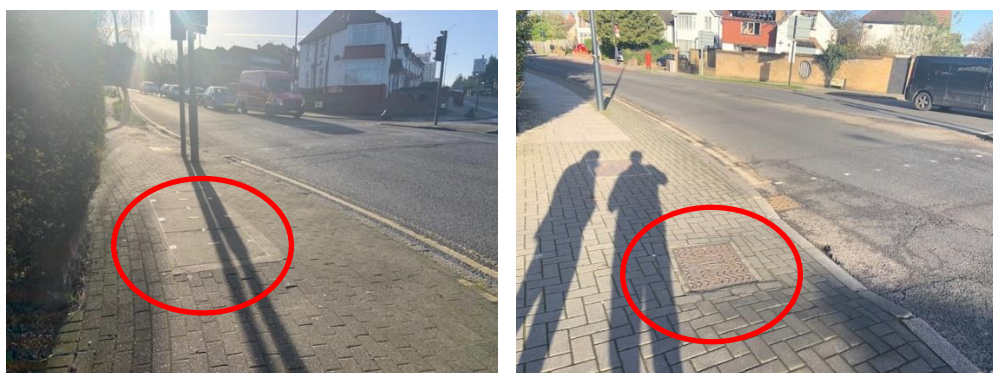
## 2.6 PROBLEM

General - Service covers in pedestrian crossing points

Summary: Potential hazard to pedestrians

There are numerous service covers in the footways around the junction that are likely to be within the proposed tactile paving areas of the puffin crossings. If the tactile paving is interrupted by the covers, visually impaired pedestrians may be at risk of stepping into the carriageway via the covers without recognising the warning paving, with the risk of being struck by vehicles.

The service covers should be replaced with recessed service cover lids infilled with tactile paving.

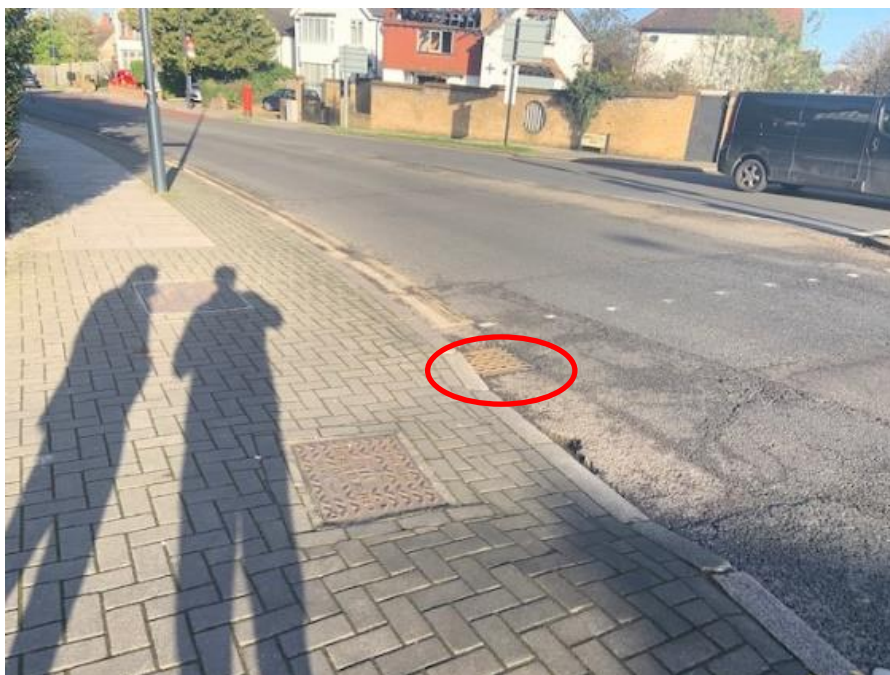
## 2.7 PROBLEM

Location - Wembley Hill Road (N)

Summary: Potential slip and trip hazard to pedestrians

There is an existing drainage gully on Wembley Hill Road (N) that is likely to be adjacent to the dropped kerbs of the puffin crossing on the west side of Wembley Hill Road (N). The gully, if within the crossing path may be a potential trip and slip hazard to pedestrians.

The gully should be relocated from the dropped kerb and tactile paving of the crossing.

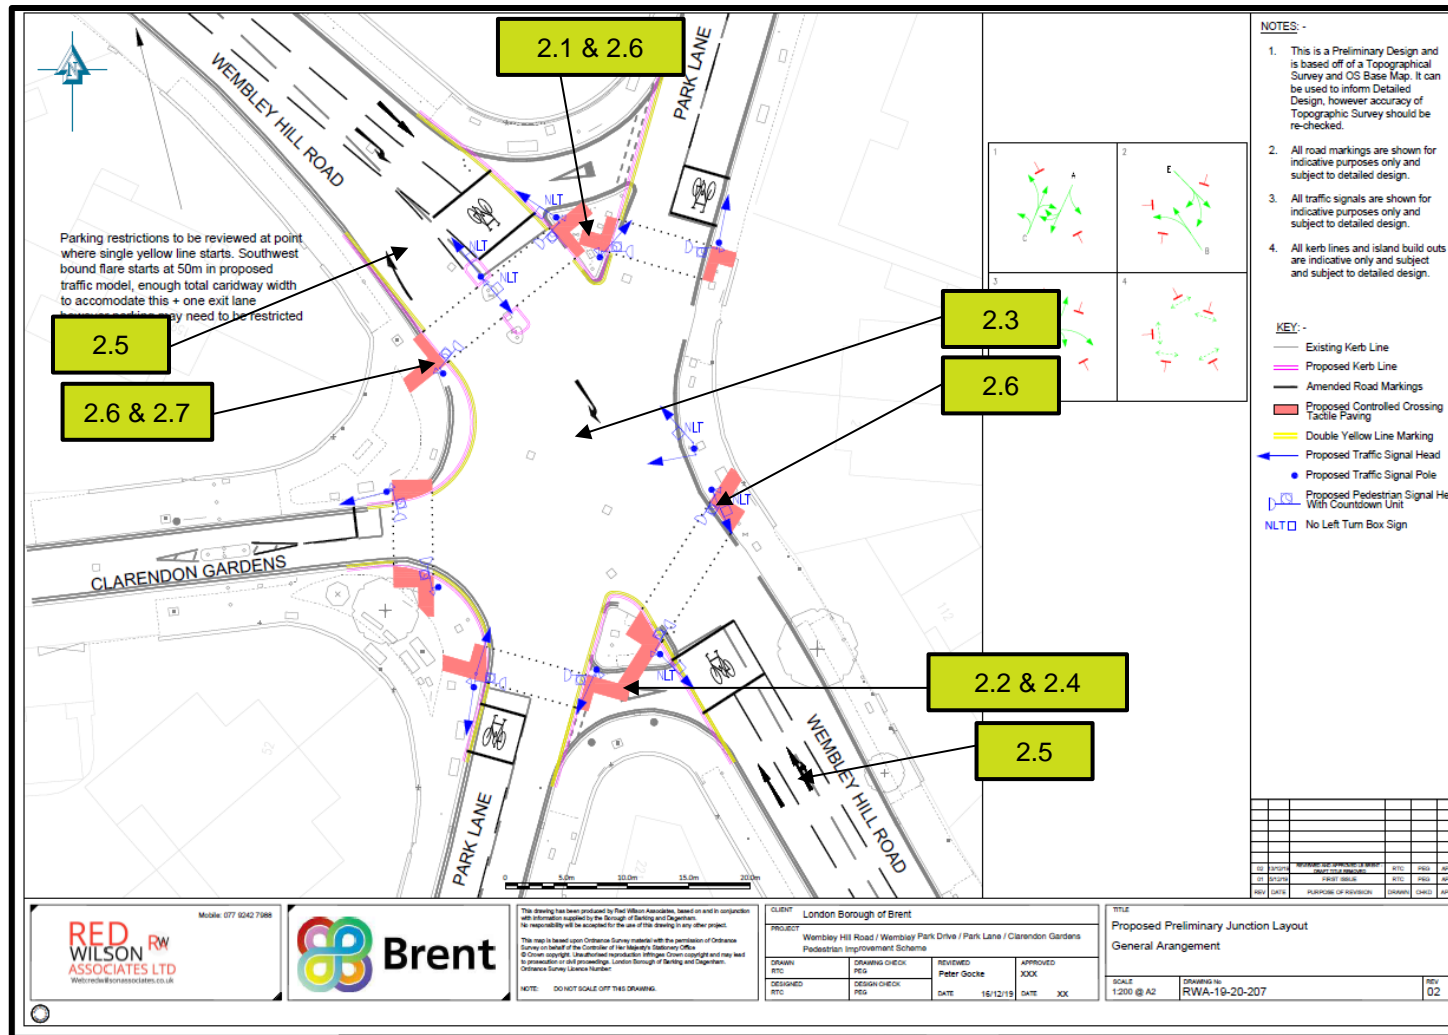
## Appendix B

Please refer to the following page for a plan illustrating the locations of the problems identified as part of this audit (location numbers refer to paragraph numbers in the report).
